Optimization Review Report Operation and Maintenance Optimization Study

**Reynolds Metals Company Superfund Site
Multnomah County, Oregon
EPA Region 10**

REYNOLDS METALS COMPANY SUPERFUND SITE, MULTNOMAH COUNTY, OREGON EPA REGION 10

FINAL REPORT
September 2018

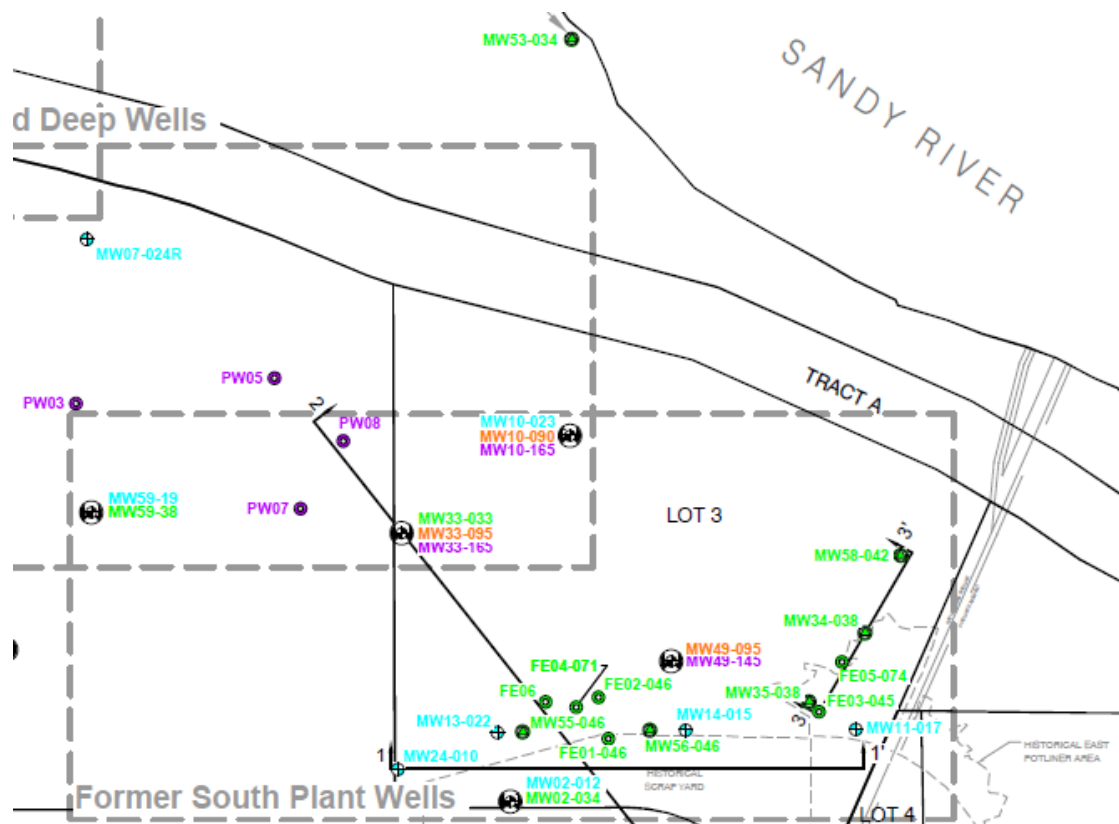
- The FE component of the system involves extraction from two focused extraction wells (FE wells) in the upper gray sand near the Scrap Yard. Up to five FE wells have been used for this purpose since the remedy began. At the time of the optimization review, FE05 and FE06 were in operation. These wells were originally capable of maintaining extraction rates over 40 gallons per minute (gpm), but the extraction rates have decreased over time due to fouling and plugging of the wells or conveyance piping. Previous FE wells FE01, FE02, and FE03 also were impacted by fouling or scaling. The operational history of these well is graphically displayed in Figures 26 and 27 from the 2016 Annual Report (APEX, 2017), which are provided in Appendix B. The fluoride concentration on FE05 was decreased to under 10 mg/L. The fluoride concentration in FE06 remains above 40 mg/L. (See Figure 2 for FE well locations.)

- The PWO component of the system involves extraction from up to four of the former production wells installed in the deep sand/gravel. The primary former production wells that have been used over the past several years are PW07 and PW08. The average pumping rate for each well is over 800 gpm. The PWO system typically extracts approximately 2.5 million gallons of water per day with a fluoride concentration of approximately 2 mg/L and a typical mass removal rate of over 30 pounds per day. The primary purpose of the PWO system is to capture contamination that was already in the intermediate sand or deep sand/gravel and dilute the fluoride contamination from the FE wells such that the blended water is under the NPDES discharge requirement of 5 mg/L. (See Figure 2 for PWO well locations.) By continuing to operate, the PWO wells continue to pull fluoride contamination into the intermediate sand and deep sand/gravel, perpetuating the use of the PWO system for addressing contamination in those deeper zones.

Figure 2: Locations of FE wells (FE02, FE03, FE04, FE05, FE06) and PWO wells (PW03, PW05, PW07, PW08). Refer to the outlines of the Historical Scrap Yard, Historical East Potliner Areas, and Sandy River to reference locations relative to historical features (APEX, 2017). All figures reproduced in Appendix B.
